Documentation of a miraculous transformation

DOWNTOWN OCALA

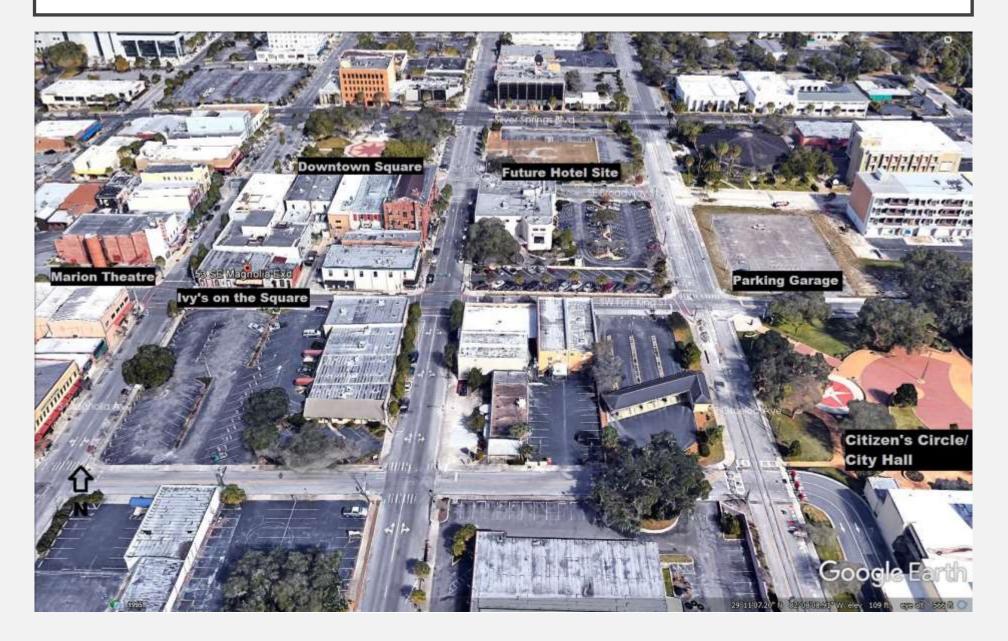
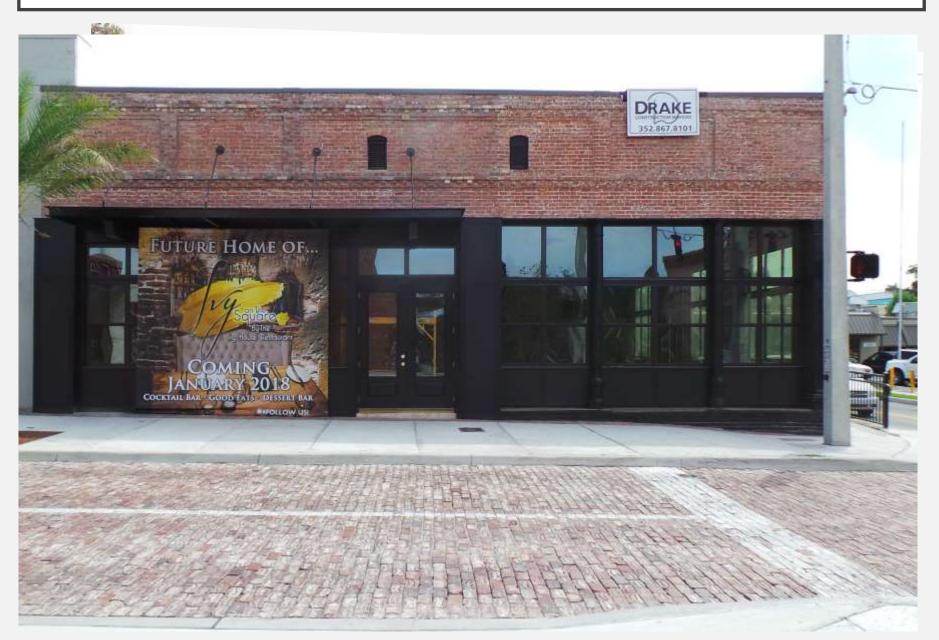
- View from Magnolia Avenue prior conditions circa 2014-2016.
- Historic façade elements covered over.
- View from Magnolia Avenue across from iconic Marion Theatre | after façade work completed.

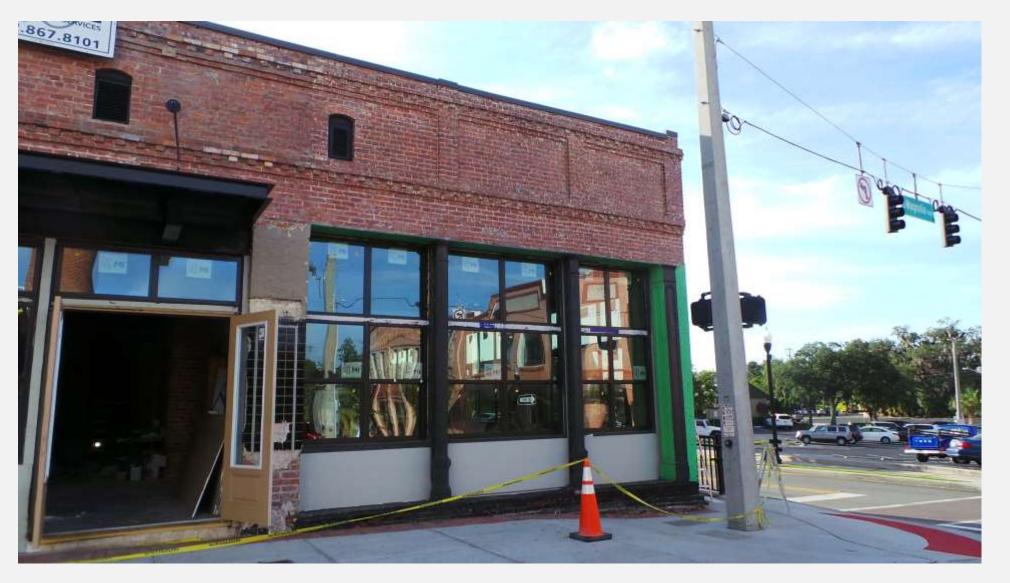
- Magnolia Avenue façade during construction.
- Original red brick restored.
- Inappropriate façade covering removed.
 - Newly created transparency connects interior to sidewalk and public realm.

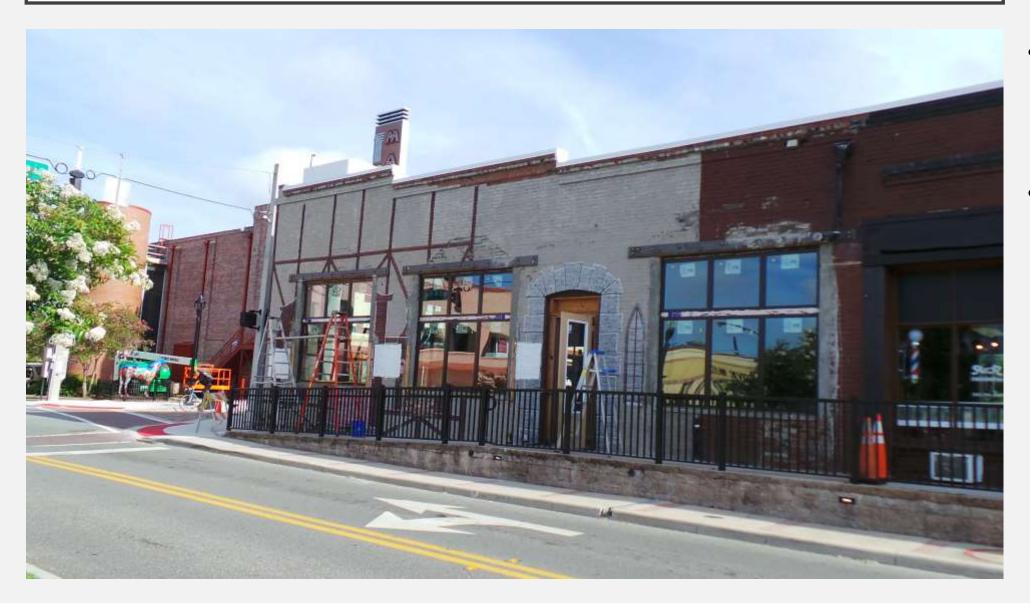
- View from Fort King Street during construction |
- Walls cut to add windows on the sidewalk.

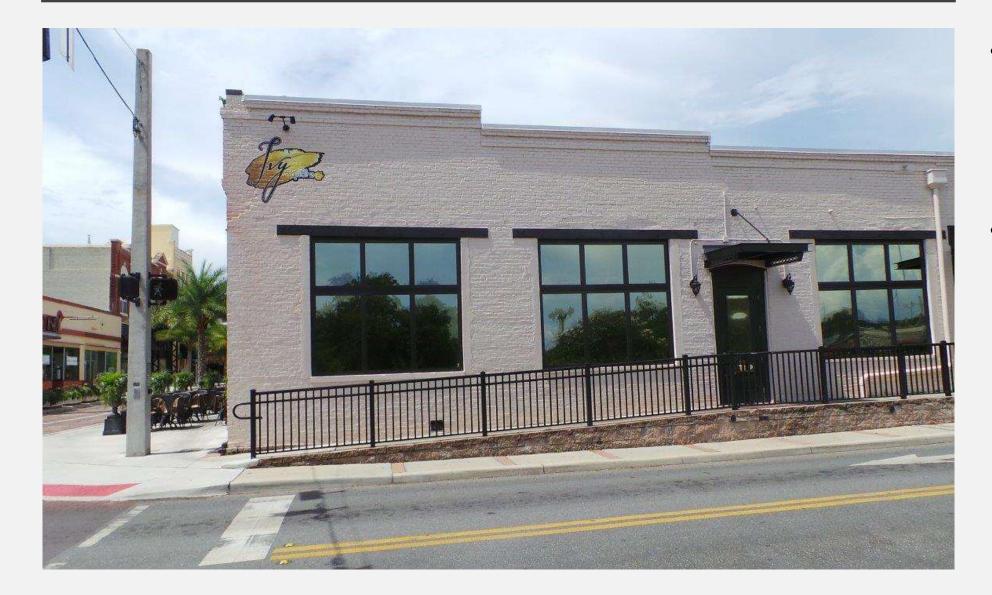
- View from Fort King Street | prior conditions | circa 2014 – 2106.
- View after completion | ADA accessible ramp and improved facades with large windows.

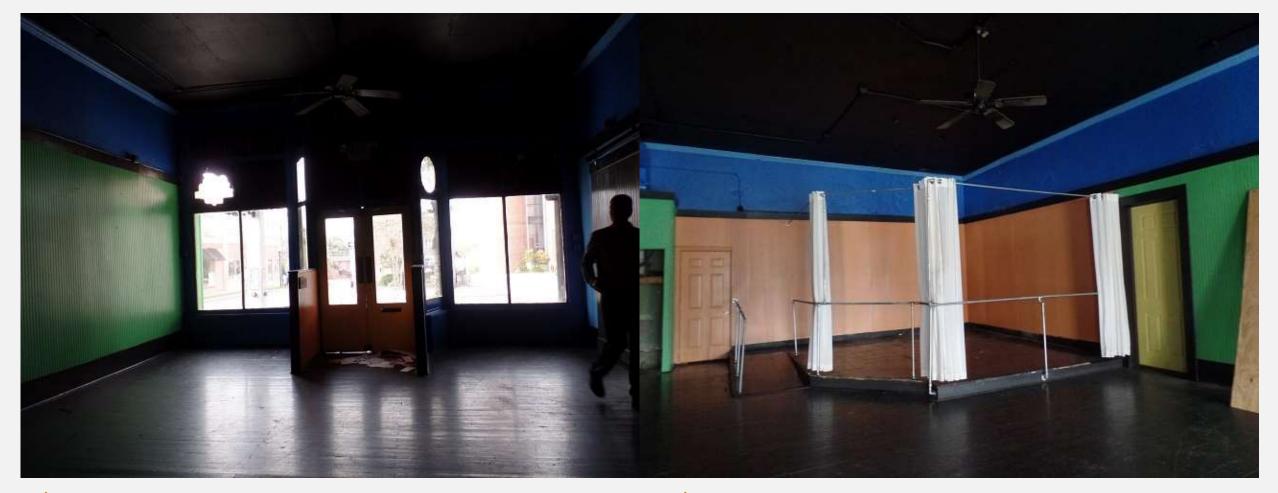
1 Dining area, before – west wall facing Magnolia Avenue 1 Rear of dining area, before – north wall

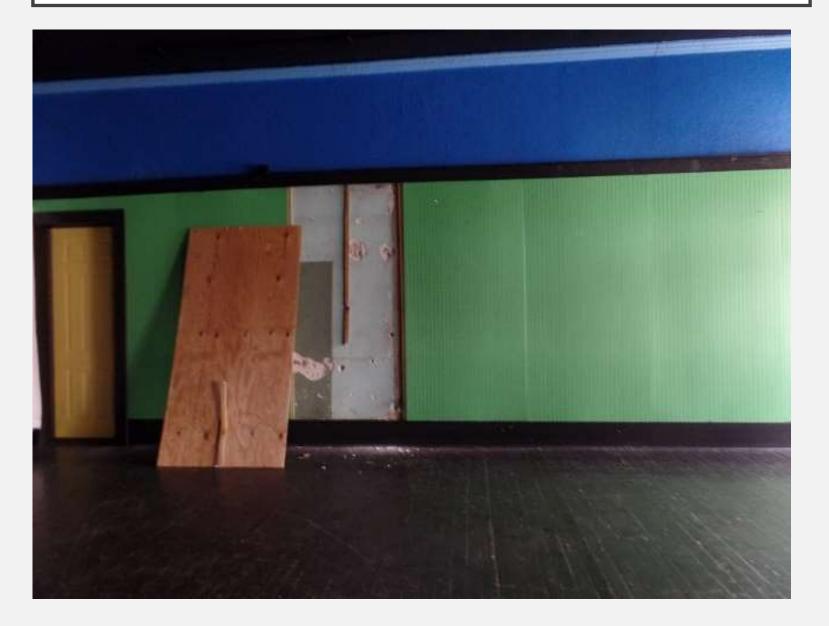
Dining area before – south wall facing Fort King Street

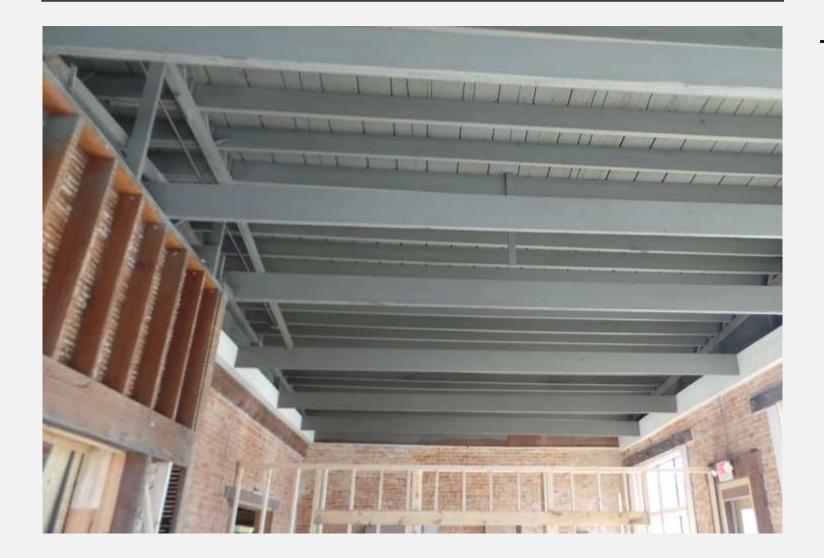
IVY'S DINING ROOM - CEILING

Transformation of ceiling to 19th century barroom chic.

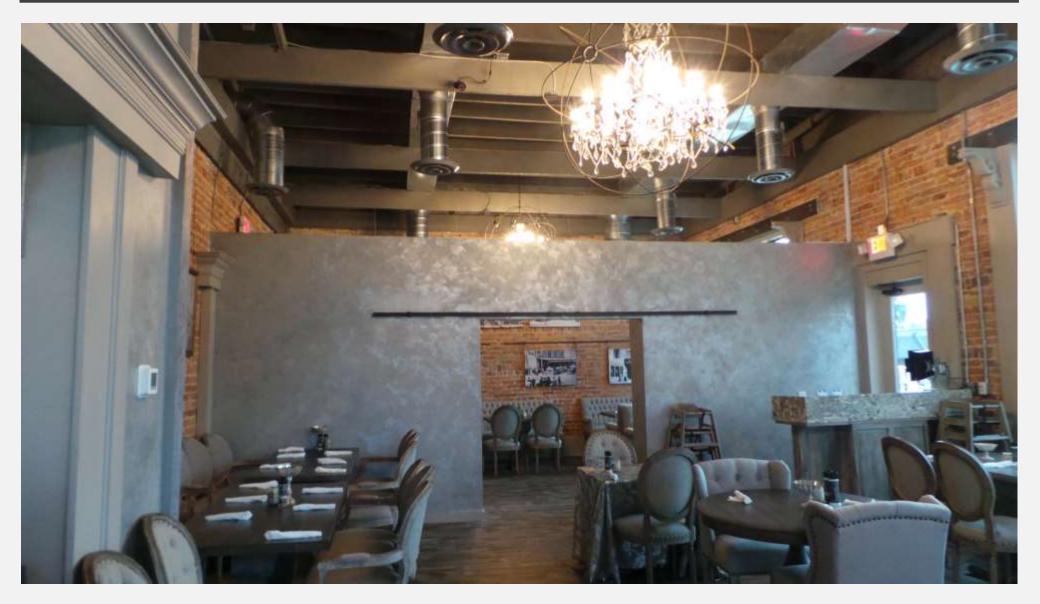
Ivy's dining room before and after renovations.

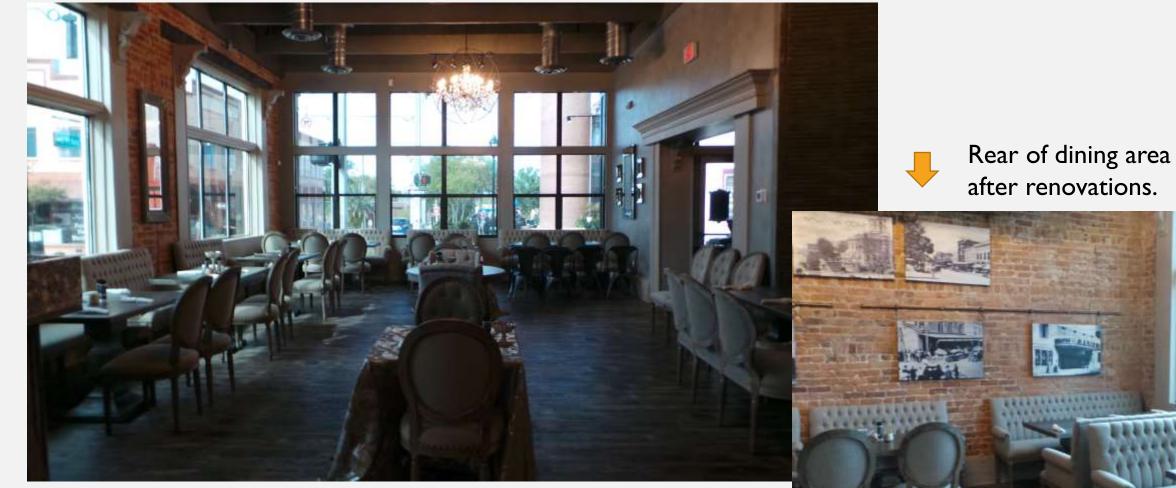
View west towards Marion Theatre | dining area after renovations.

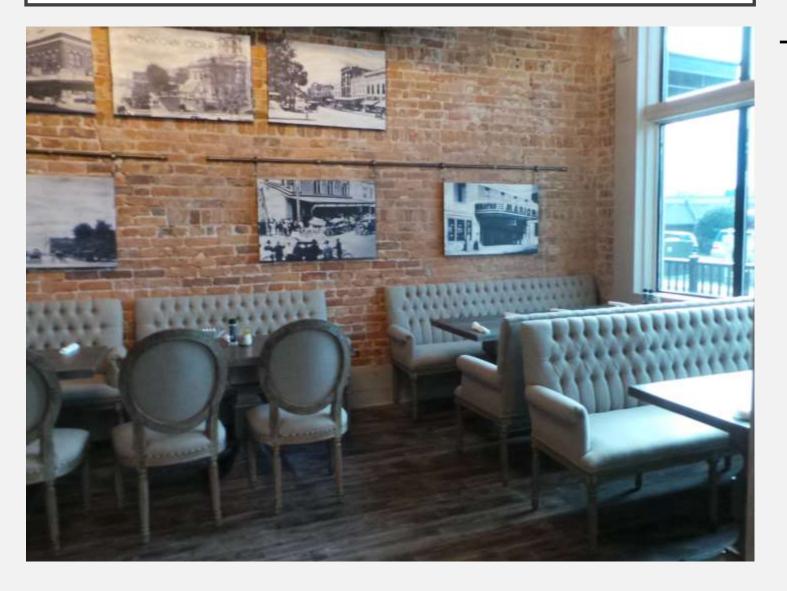
Transformation of rear dining area.

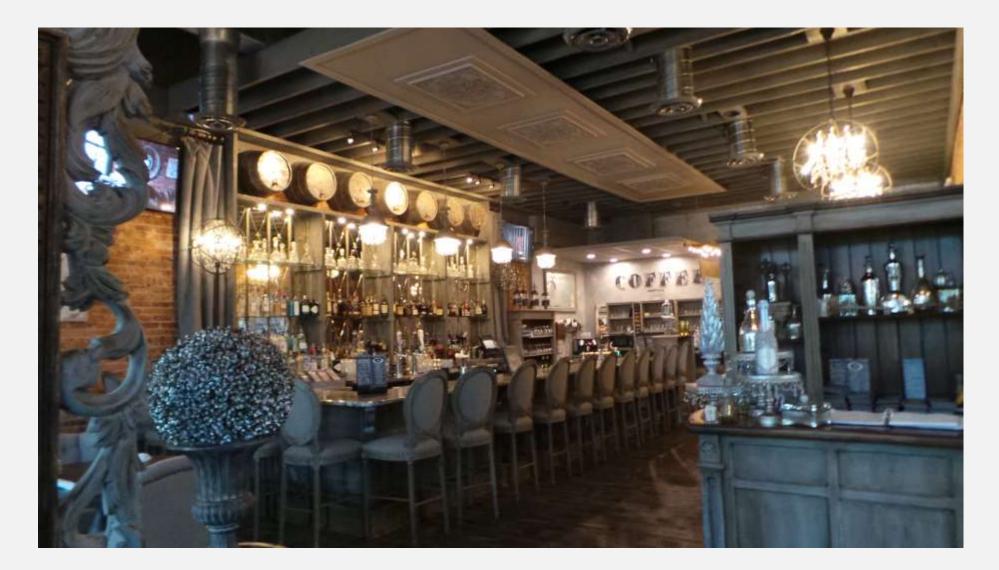
IVY'S – CREATING A MAGNIFICENT COCKTAIL LOUNGE

Bar area before, during construction, and after completion.
