## Phase I Environmental Site Assessment EPA Cooperative Agreement #BF 95481611-0

# Former Hacienda Hotel Property 5621 Main Street New Port Richey, Pasco County, Florida Parcel ID No. 05-26-16-001A-00300-0010

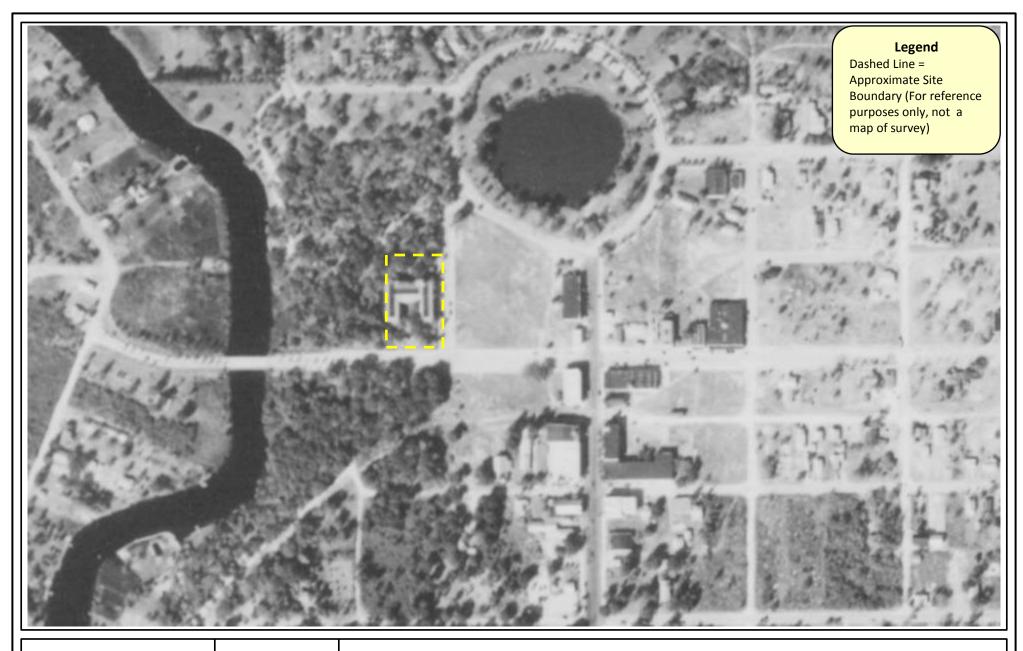
Figure 4a Aerial Photograph - 1941

Aerial Photograp	h Review Results:							
1941, 1952, 1967, Visible features in the photos appear consistent with on-site features noted during the recent site visit.								
Sanborn Fire Insurance Map Review Results:								
1926	While just a portion of the subject site is depicted, no structures are visible within the site boundaries.							
1933, 1947	Similar to the 1926 map, the west boundary of the site is not depicted. structure consistent with the current on-site structure is depicted and labeled as "Hotel Hacienda."							
Historical City Directory Review Results:								
1957, 1961	Listed as "Hacienda Hotel"							
1975, 1980, 1984	Listed as "Hacienda Motor Lodge"							
1995	Listed as "Gulf Coast Jewish Family Services"

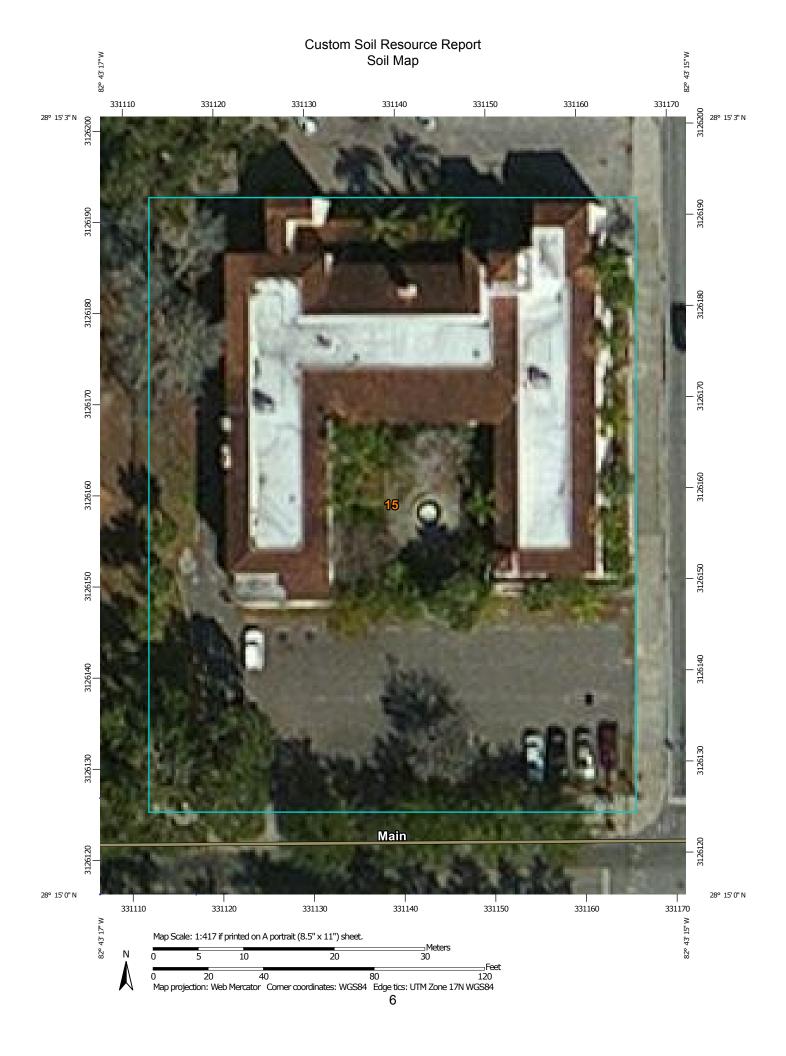
# Soil Map

The soil map section includes the soil map for the defined area of interest, a list of soil map units on the map and extent of each map unit, and cartographic symbols displayed on the map. Also presented are various metadata about data used to produce the map, and a description of each soil map unit.

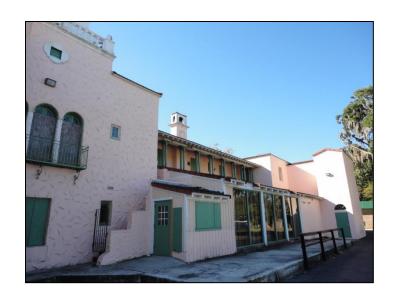
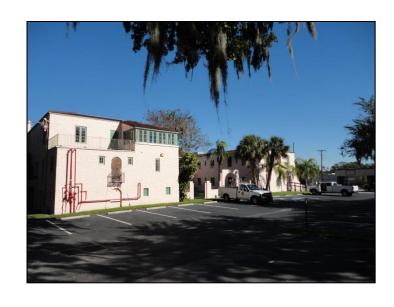
Left and Right. Typical exterior views of the subject site structure.

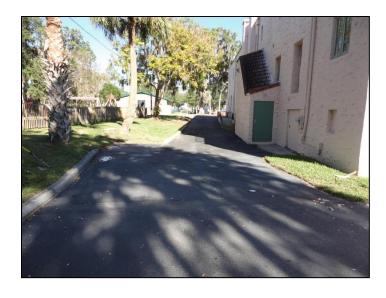
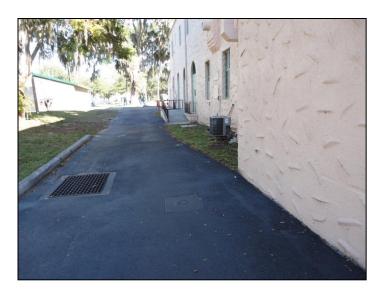
- An underground propane tank was observed near the western edge of the property (not an REC). The maintenance supervisor interviewed as part of TBE's 2003 investigation reported the tank was used for the kitchen's gas appliances.

Left and Right: Views of the west side of the onsite structure (location of former UST).

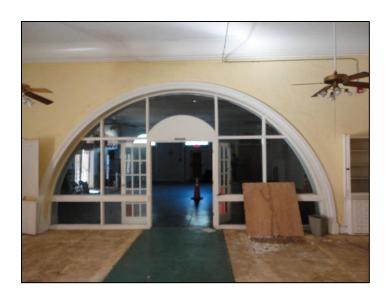
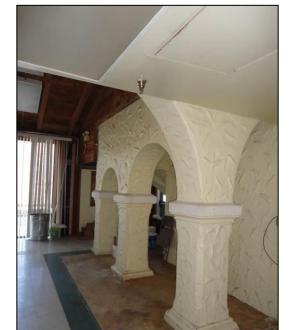
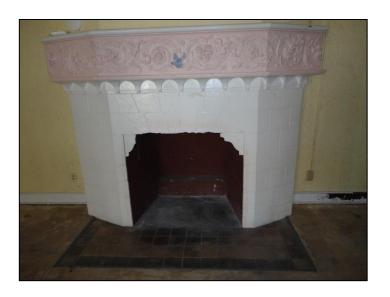
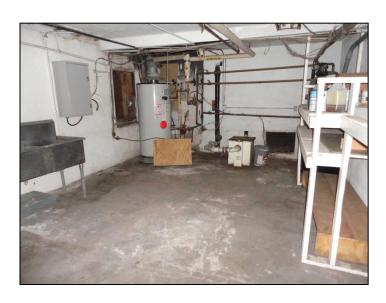
Typical interior views of the subject site structure. Top right photo is of the fire place with lead-based paint.
